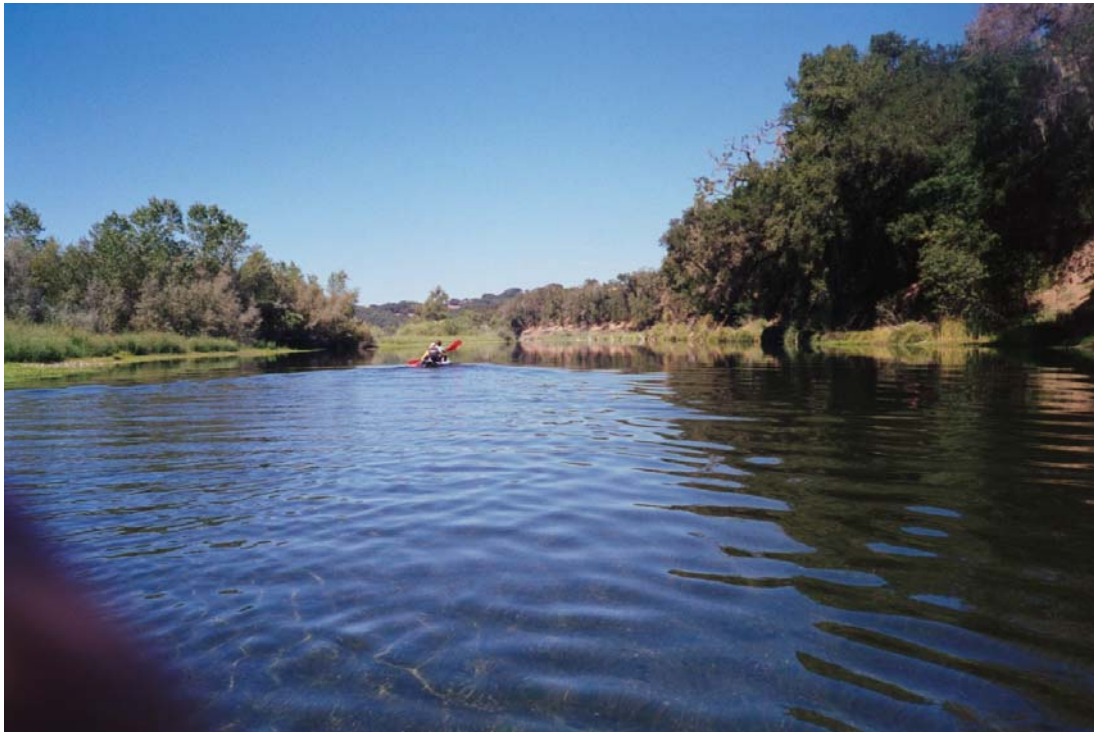
Figure 42: Healdsburg Reach, Segment H5. This segment was not dive surveyed but contained primarily flatwater habitat.

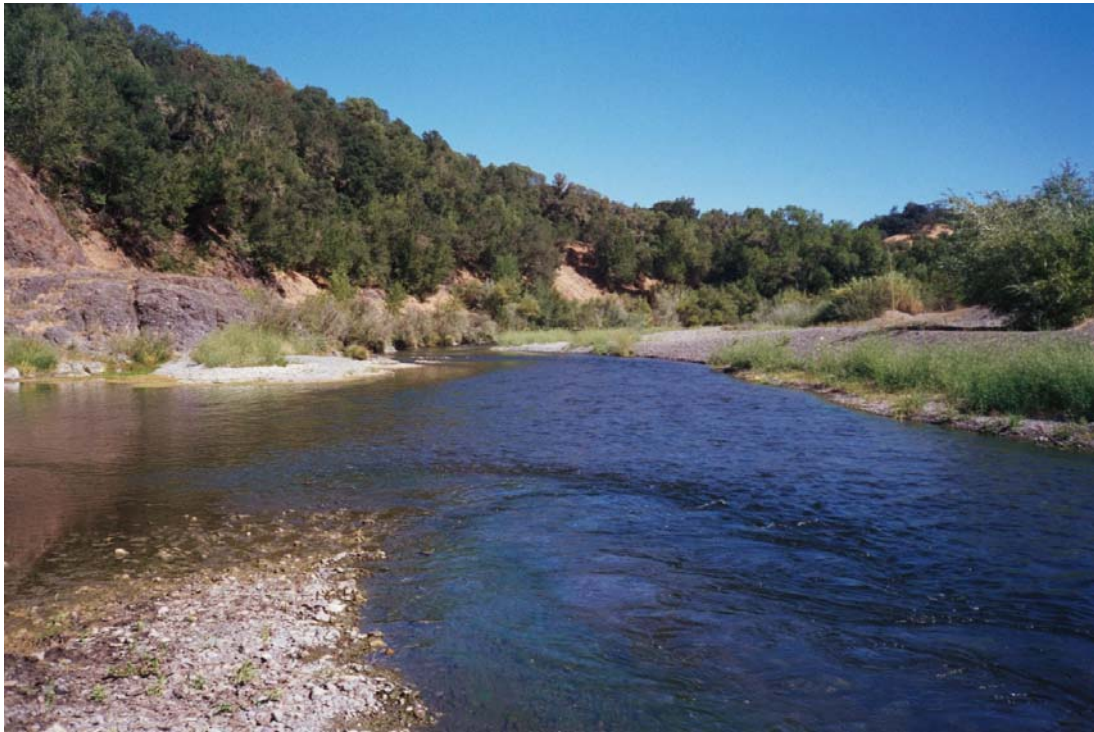
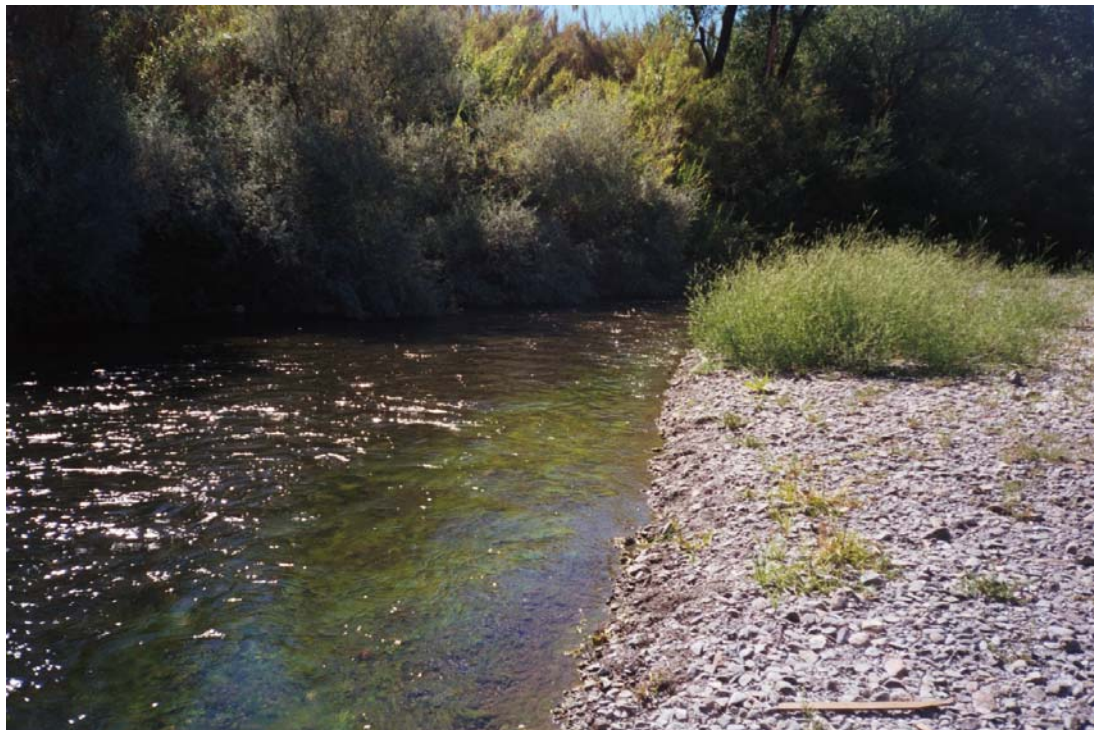
Figure 43: Healdsburg Reach, Segment H6. This segment contained 3% riffle, 94% flatwater, and 3% deep pool habitats. One steelhead was observed in a small riffle (bottom).

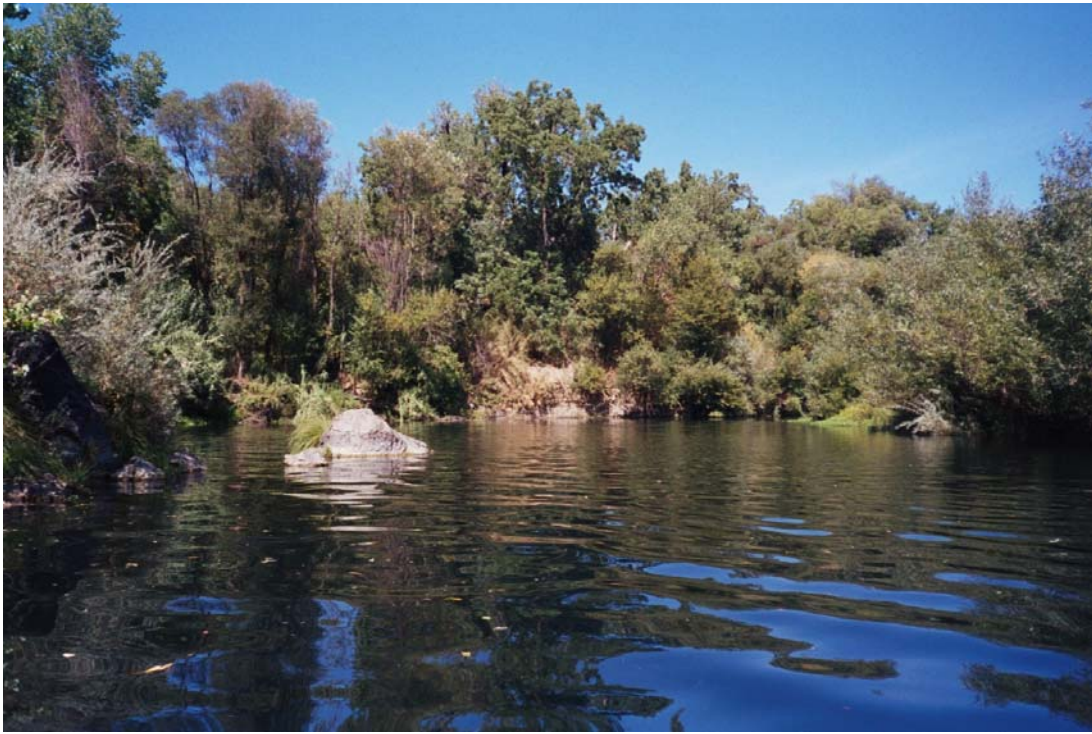
Figure 44: Healdsburg Reach, Segment H7. This segment was not dive surveyed but contained a large deep pool and flatwater habitats.

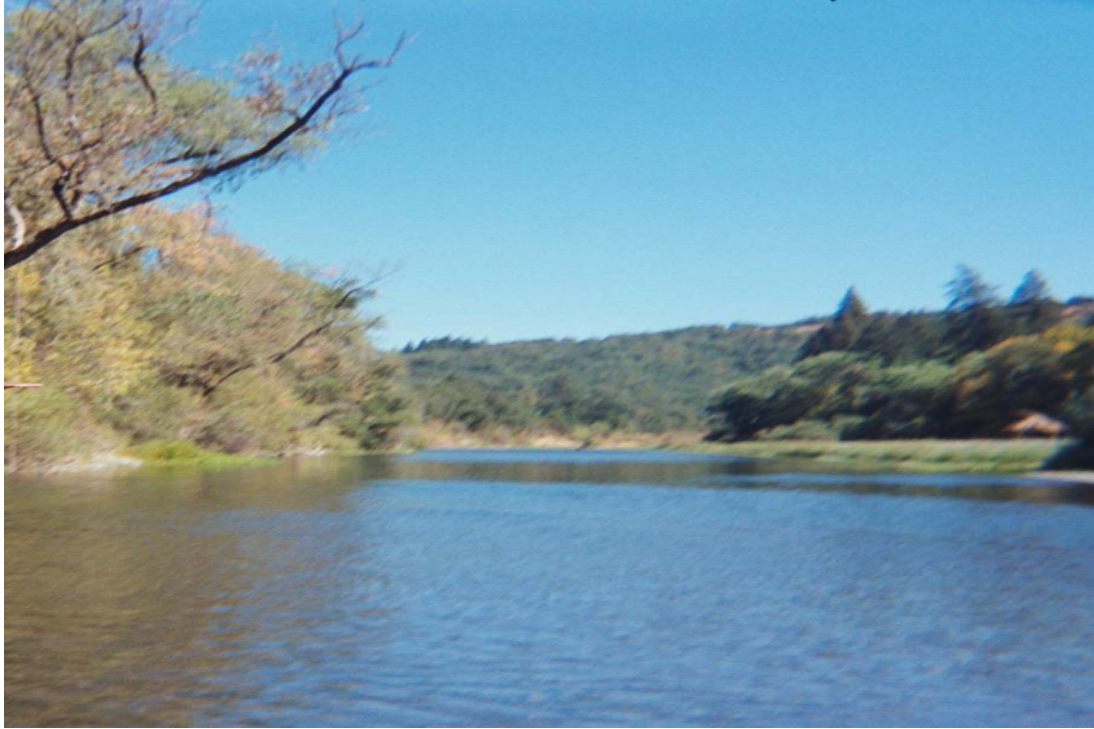
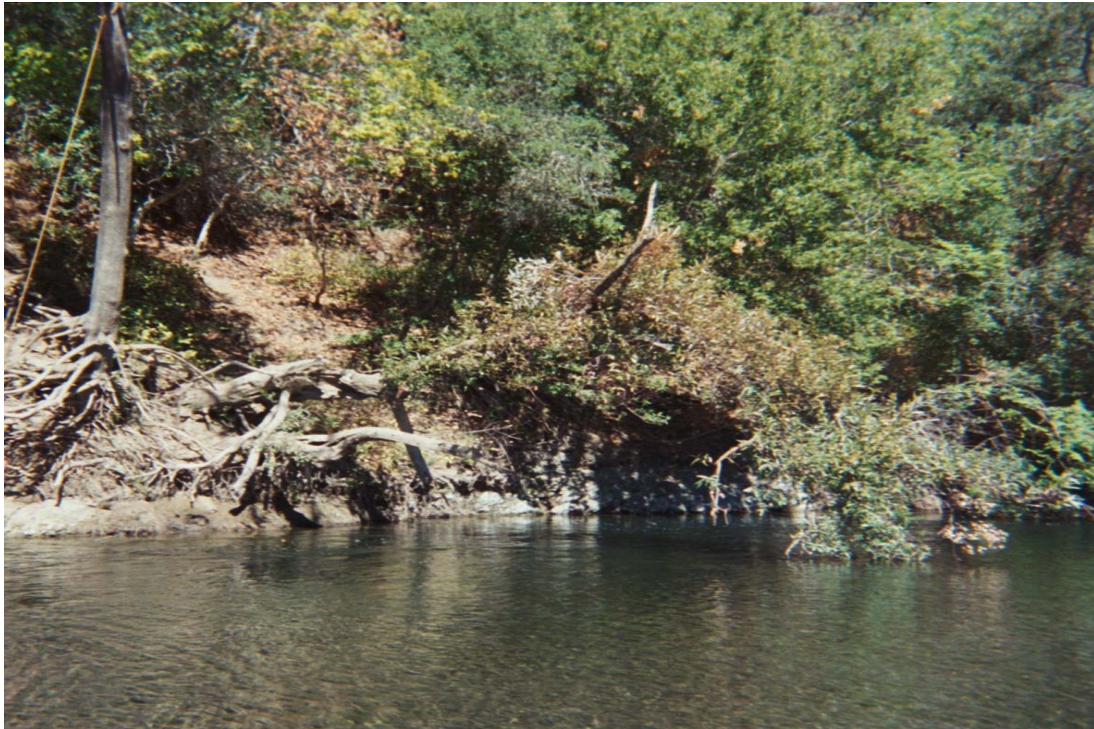
Figure 45: Healdsburg Reach, Segment H8. This segment contained primarily flatwater habitat. No steelhead were observed.

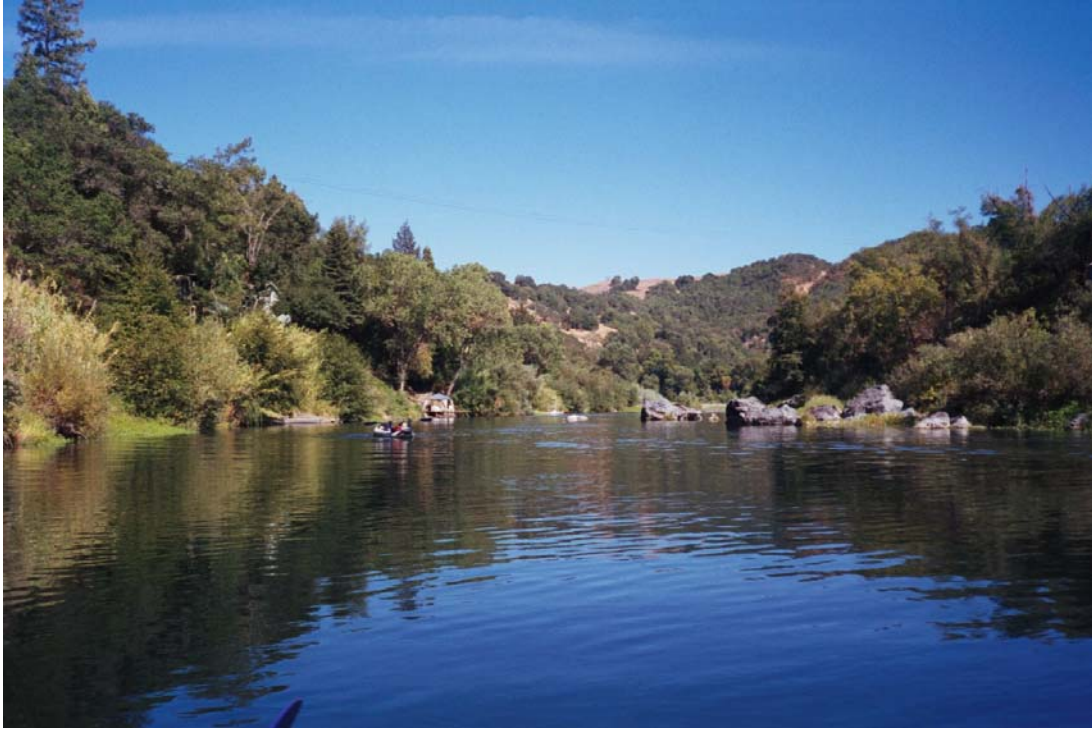
Figure 46: Healdsburg Reach, Segment H9. This segment was not surveyed but contained deep pool and flatwater habitats. Water conditions are influenced by the Healdsburg Dam located approximately 4 km downstream. No steelhead were observed.

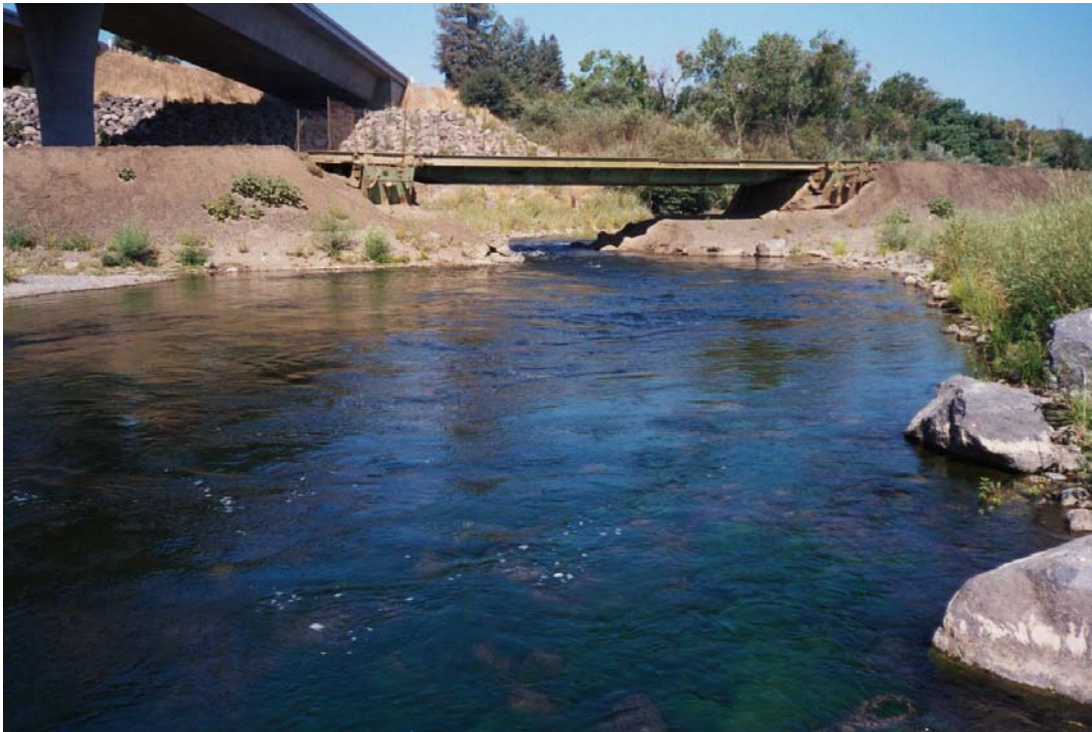
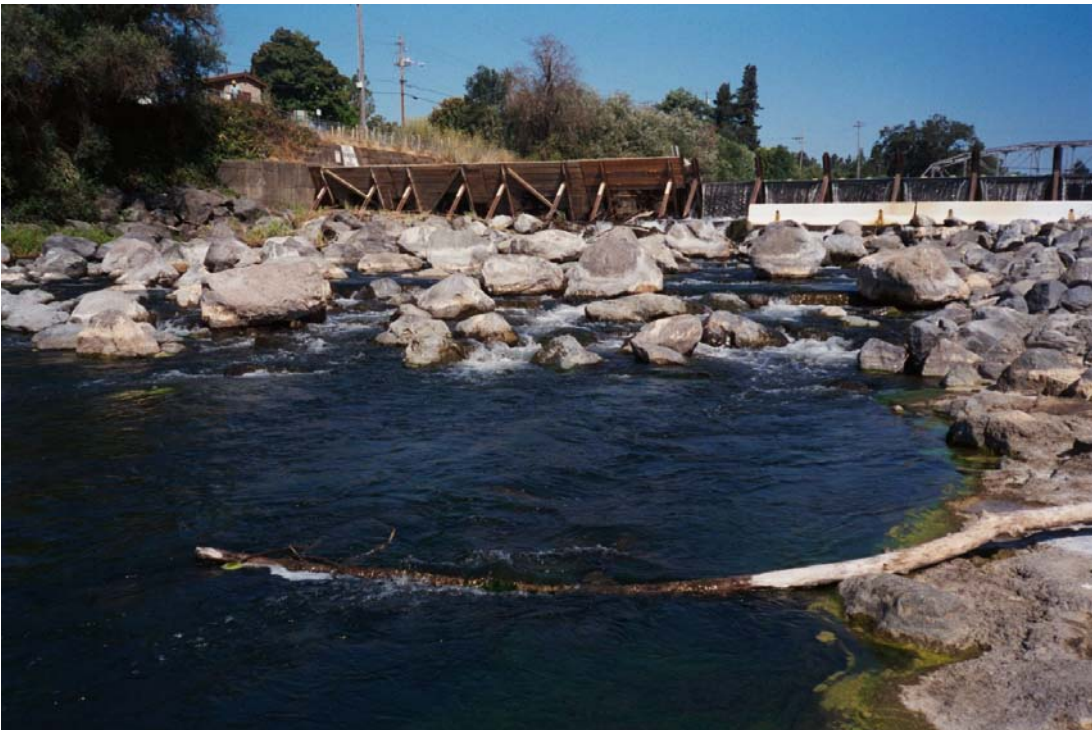
Figure 47: Healdsburg Reach, Segment H10, Healdsburg Dam. This segment is located at and below the Healdsburg Dam and contained 3% deep pool, 78% flatwater, 12% riffle, and 7% cascade habitats. The photographs show a fast-moving deep riffle (top) and an artificial cascade below the dam (bottom). A total of 16 steelhead were observed in the riffle and cascade habitats.
